**Tan y Graig Farm, Pentraeth**  
**ENABLING DEVELOPMENT STATEMENT**  
Grŵp Amos Cymru Cyf  
April 2024  
2017.057\_03

## Enabling Development Statement

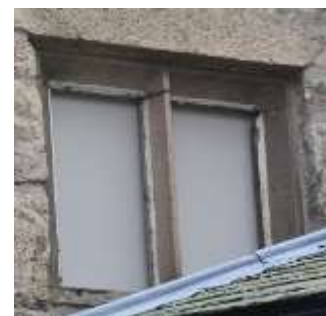
The window surround to W23 in Room F3 (Photo 3) has open joints noticeably to the left hand side, these are to be raked back and re-pointed in the designated lime mortar.

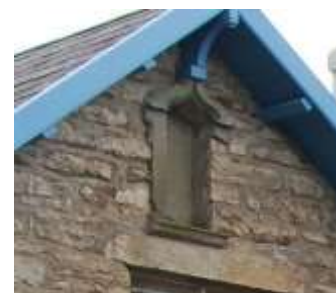
The render to the surround of the niche feature to the gable above W23 (Photo 4) has failed in parts with isolated missing patches and is to be reinstated to match original.

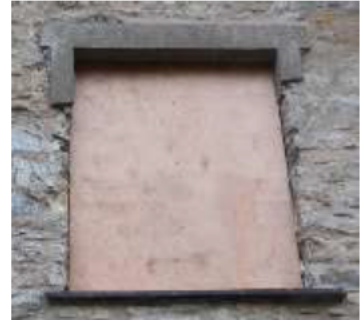
The render to the surround of window W24 in Room F6 (Photo 6) has failed in parts with isolated missing patches and is to be reinstated to match original.

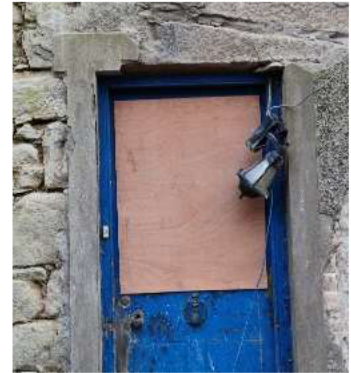
The render to the surround of door D03 in Room G10 (Photo 7) as failed in parts with isolated missing patches and is to be reinstated to match original.

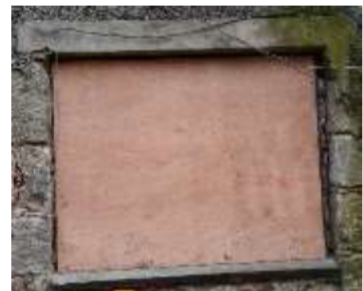
The render to the surround of window W06 in Room G13 (Photo 8) has failed in parts with isolated missing patches and is to be reinstated to match original.

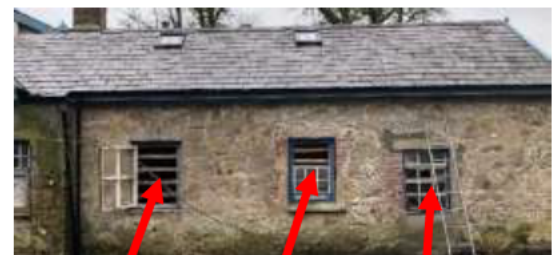
The render to the surround of windows W07 & W08 to Rooms G15 & G16 (Photo 9) respectively are missing and are to be reinstated to match original.

The render to the surround of window W09 in Room G17 (Photo 9) has failed in parts with isolated missing patches and is to be reinstated to match original.

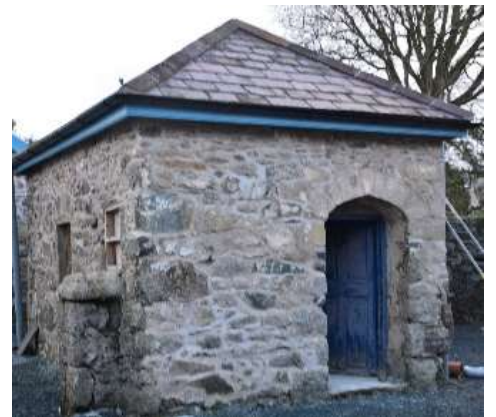
The outbuilding to the rear is in good condition and has been re-roofed and re-pointed, the former car-port adjacent to this building is to be reinstated. (Photo 14)

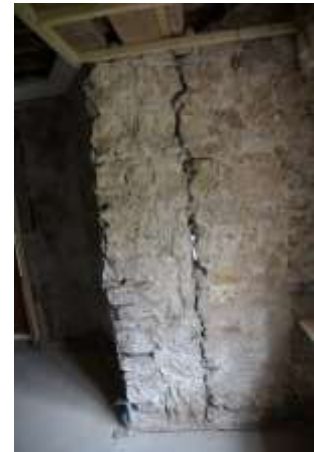
(Photo 17)

Photo 17 taken within Room G3 showing the vertical joint and lack of mechanical bond between the masonry to the ground floor extension and the original main house structure.

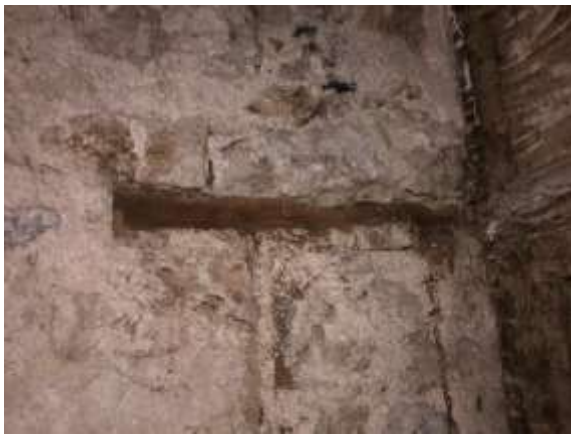
*Photo 37 - Room G1 – Rotten timber lintel to previously infilled opening.*

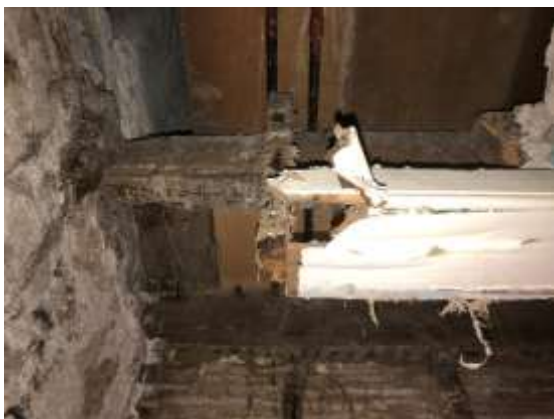
*Photo 39 - Room G1 – Dry rot to left hand door frame leading to Entrance Hall.*

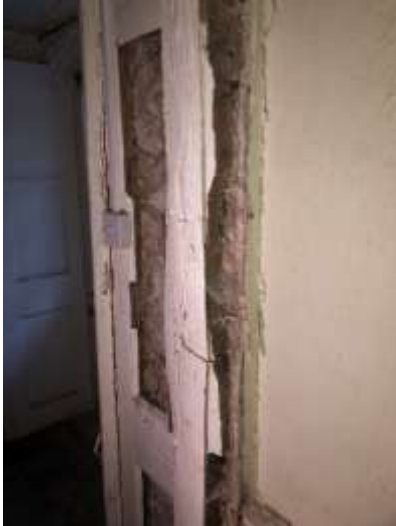
*Photo 40 - Room G1 – Dry rot to right hand door frame in G1 leading to entrance hall.*

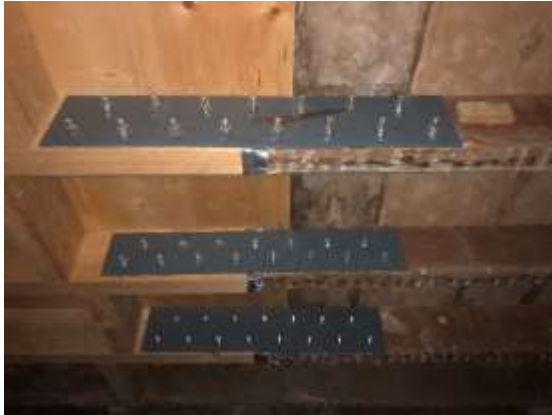
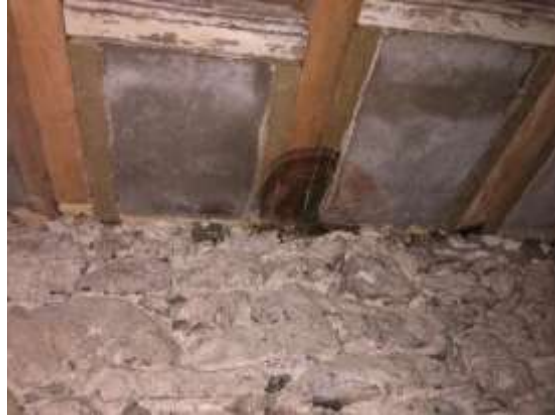
*Photos 41 & 42 - Room G2 – Previous repairs to floor joists and evidence of dry rot effecting these replacement timbers.*

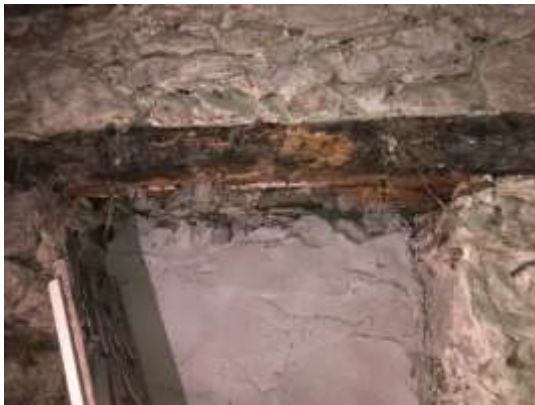
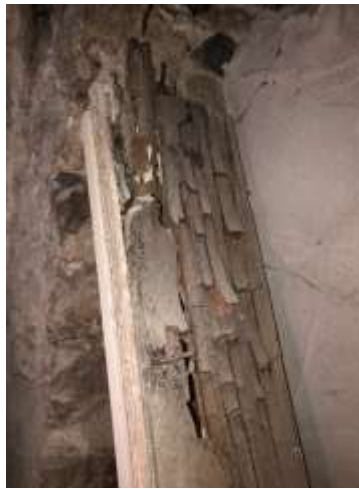
*Photos 43 & 44 - Room G2 – Dry rot within lintel and paneling to niche feature.*

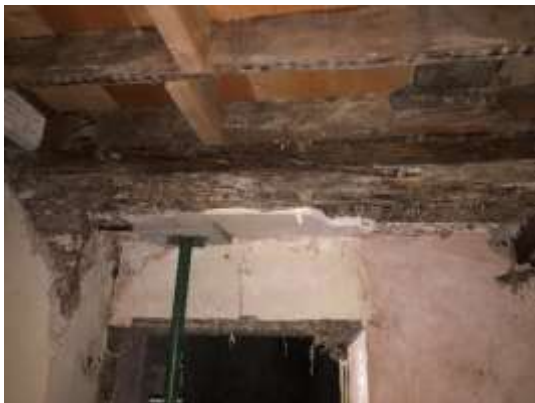
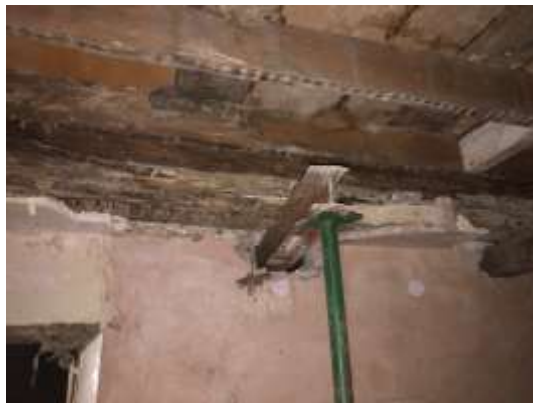
*Photos 45 & 46 – Room G2 – Dry rot to main supporting timber beam with temporary support inserted.*

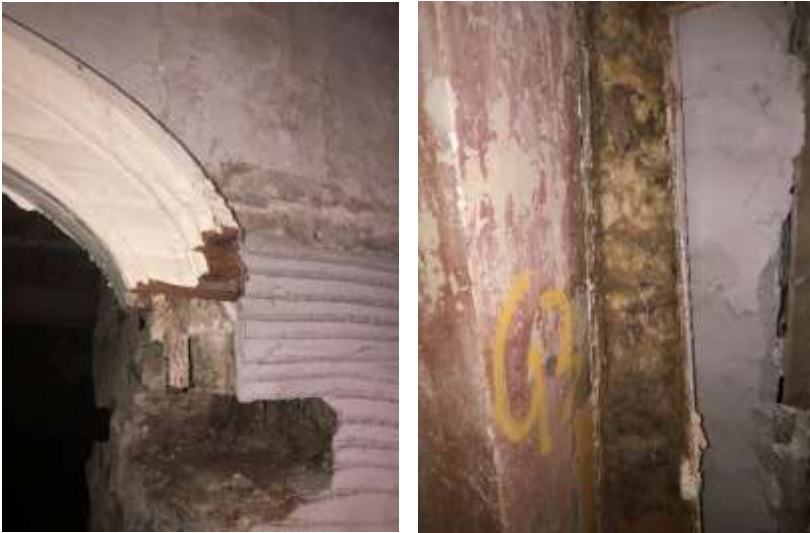
*Photos 47 & 48 - Entrance Hall doorway leading to Room F5 – Rot to door surround.*

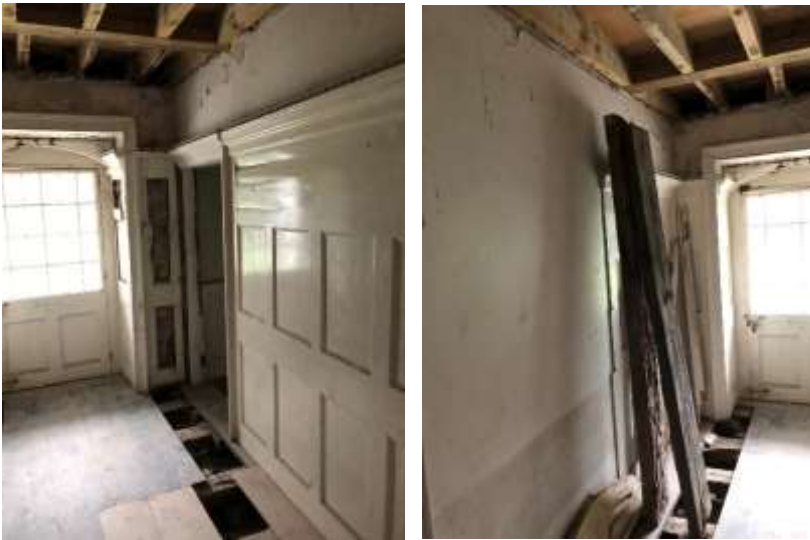
*Photos 49 & 50 – Warping to wall paneling due to presence of dry rot, missing paneling to opposite wall.*

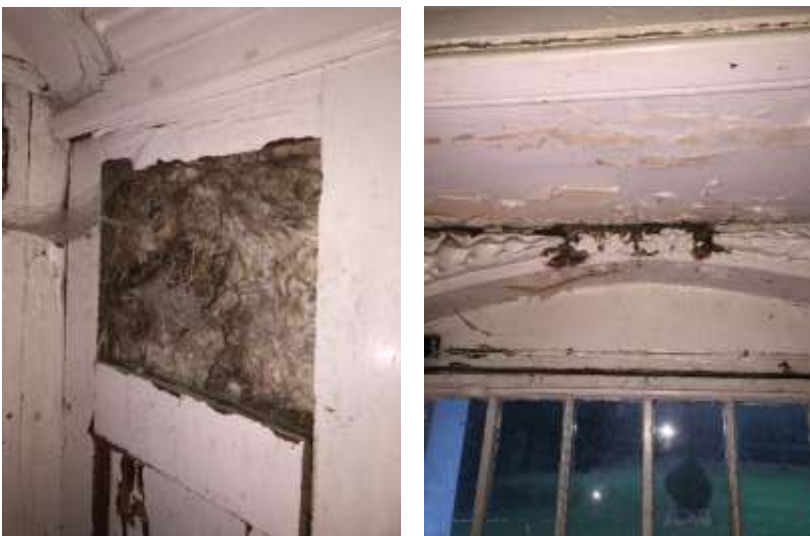
*Photos 51 & 52- Entrance Hall – Rot within paneling to right of Main Entrance door surround and evident in feature paneling above door.*

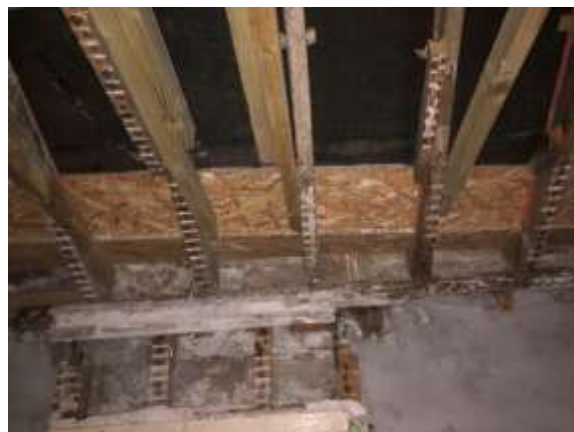
*Photo 53 - Room G3 – Replacement of rotten timber box gutter.*

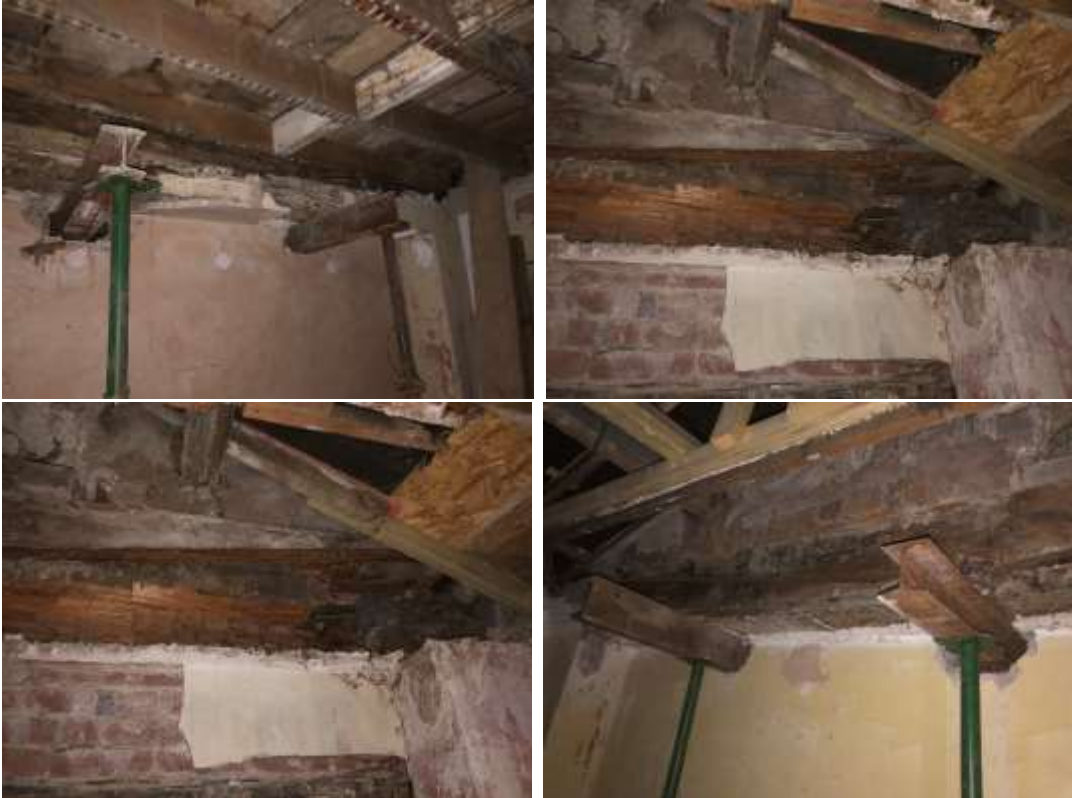
*Photos 54 to 57 - Room G3 – Rot to supporting beam between this room and G2 with corrosion to previous diagonal steel bracing bars.*

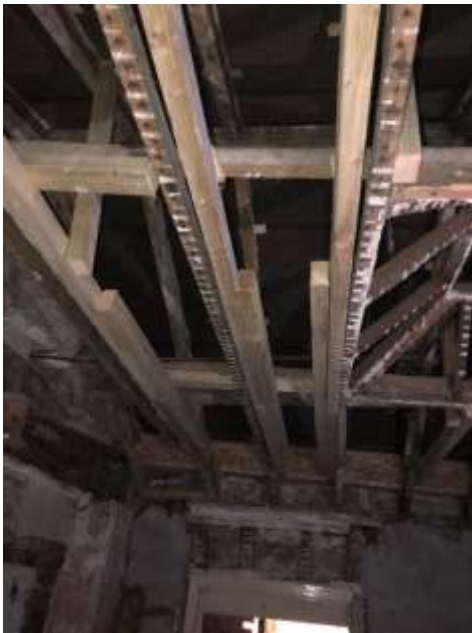
*Photo 58 - Room G3 - Splicing, bracing and replacement of rotten roof and ceiling timbers.*

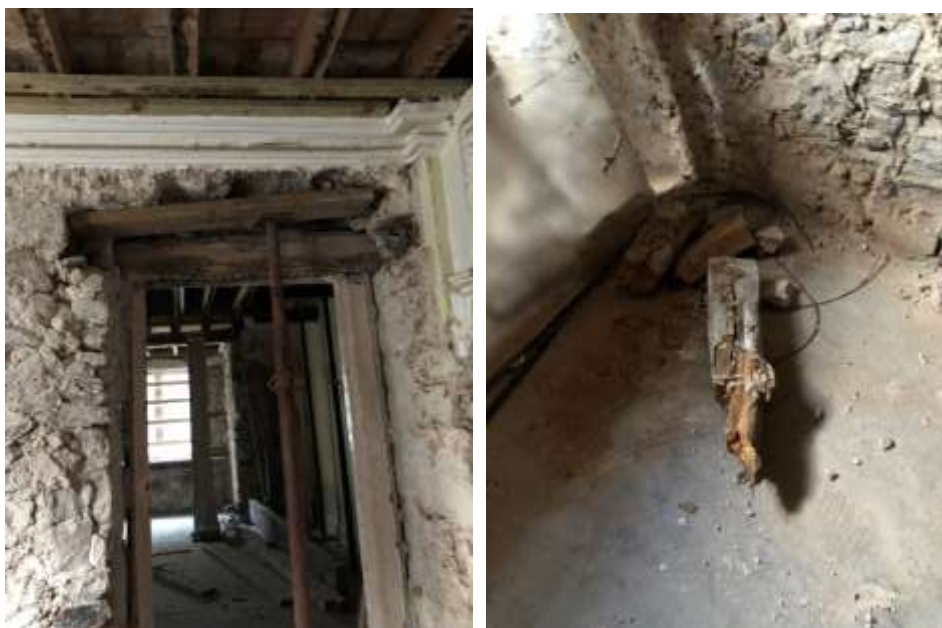
Photos 59 & 60 - Room G7 – Failure of timber lintel to doorway through to Room G3 due to rot.

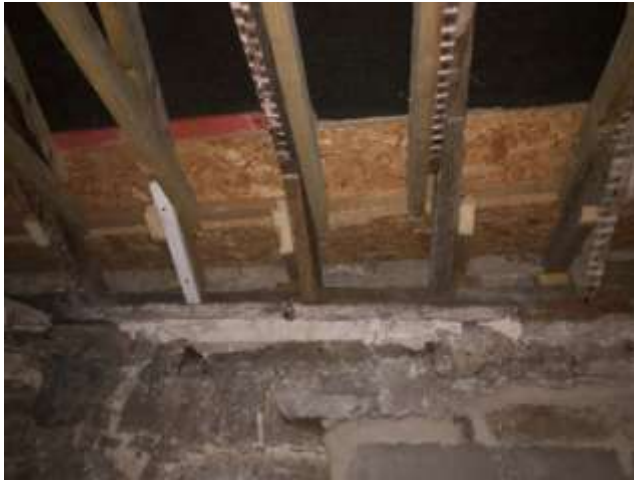
*Photo 61 - Room G4 – Replacement of rotten timber box gutter.*

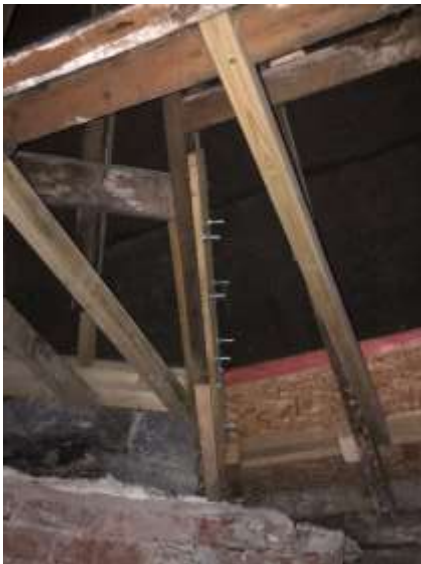
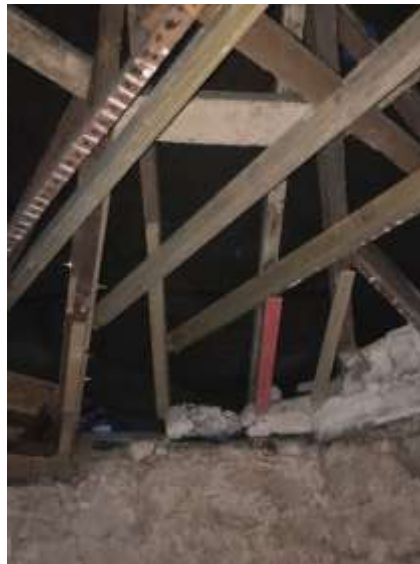
*Photos 62 & 63 - Room G4 - Splicing, bracing and replacement of rotten roof and ceiling timbers.*

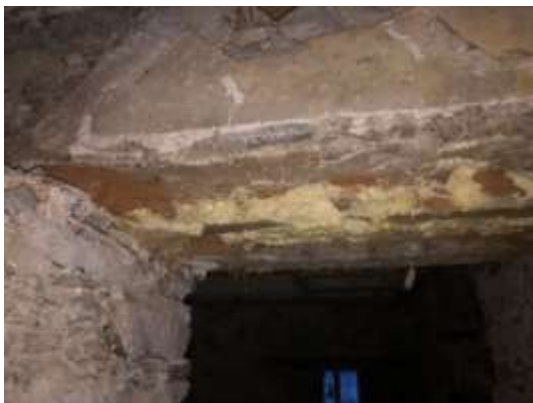
*Photo 64 - Room G5 -Rot to lintel over opening leading to Room G6, previous use of expanding foam evident, purpose unknown.*

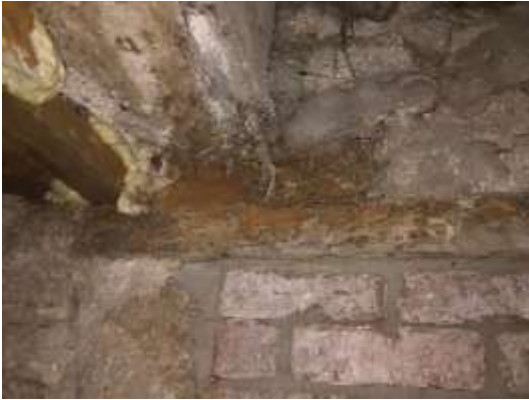
Photo 65 - Room G5 – Rot to lintel over infilled opening into Room G1.

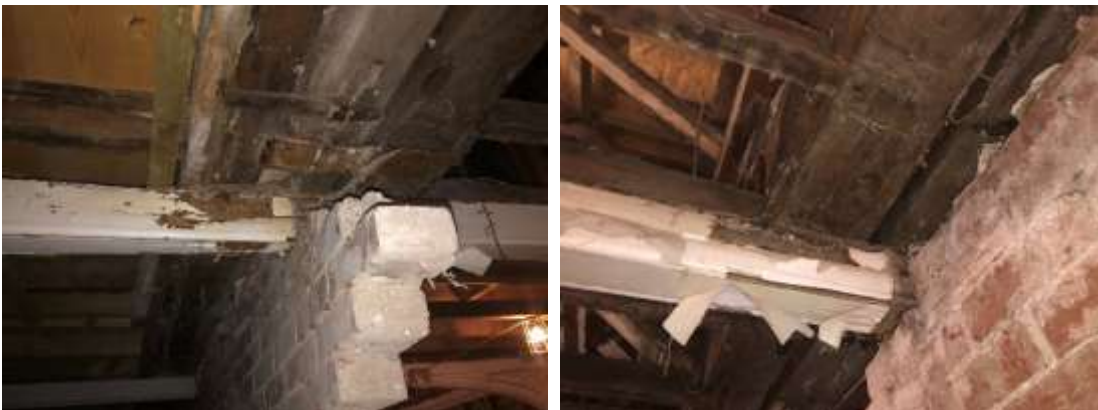
*Photos 66 & 67 - Room G7 – Rot to feature arch over later addition brick wall.*

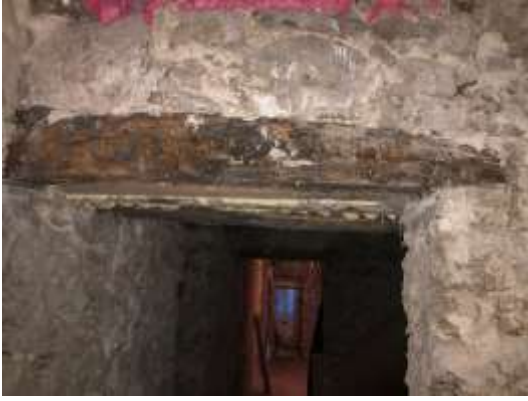
Photo 68 - Room G7 – Rot to lintel over opening leading to Room G6.

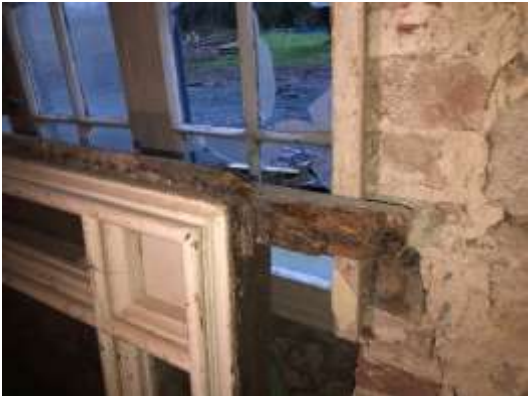
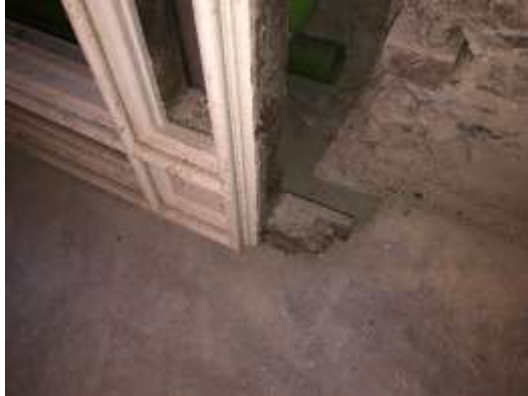
Photos 69 & 70 - Room G11 – Rot to frame of roof light requiring removal to enable repairs to be carried out.

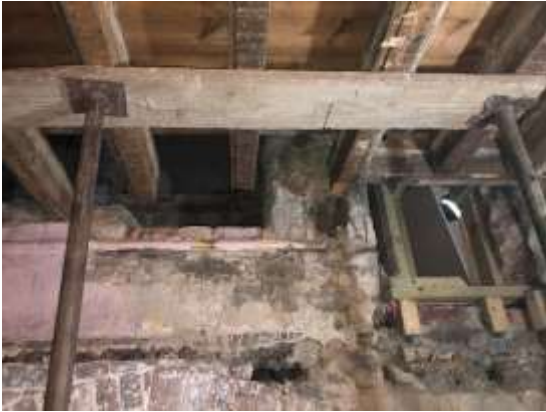
*Photo 71 - Room G8 – Rot to ends of floor joists cut out and temporary supported until repair can be carried out.*

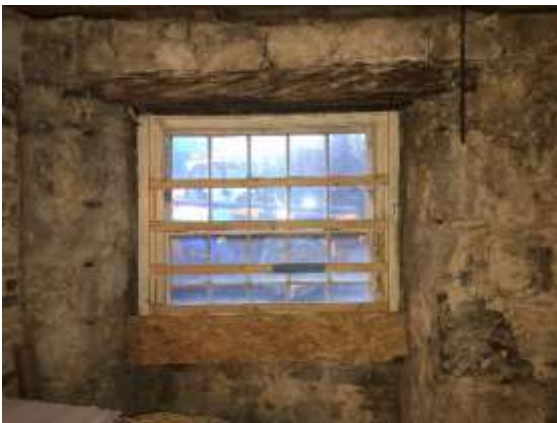
*Photo 72 - Room G8 – Rot to lintels above window W15.*

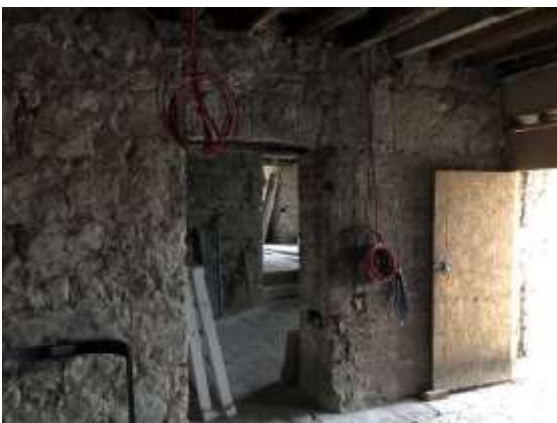
*Photo 73 – Room G8 – Brick infill to original arched entrance.*
