Bla'en Cefn Temporary Workers Accommodation
National Grid Visual Impact Provision Project-Eryri

Arboricultural Planning Assessment
(BS5837:2012)

Project no: C0233-HUK-GES-CG-AS-X-0001 Rev P02

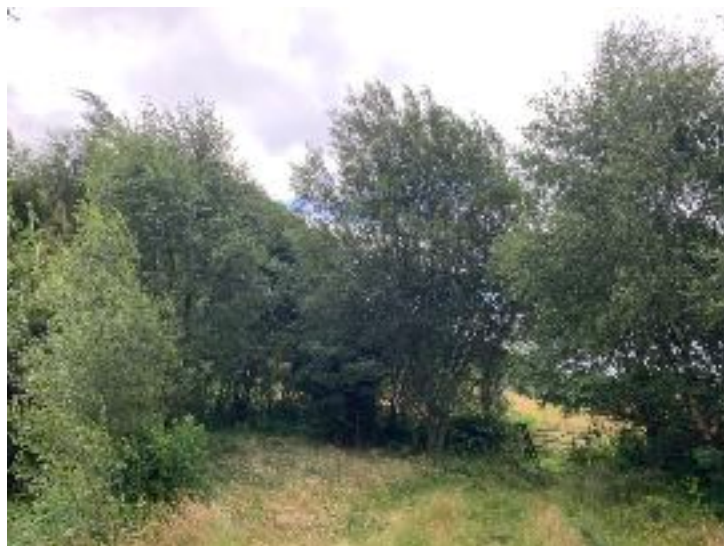
Fig 3: Western gate

The field extent which provides the basis for an access road from the A4087 features very few trees, and the proposed track does not intersect with any of them, so has not been considered from an arboricultural point of view. The western limit of the tree assessment begins at the gate leading from the west into the extent which houses the lake, and will feature the operational track into the main site. At the western end there is an intermittent hedgerow feature running broadly northwest to southeast, with a few larger trees within it. As the track progresses from west to east, we see a number of early-mature birch, willow, gorse and other scrub running between the track and the northern bank of the lake.

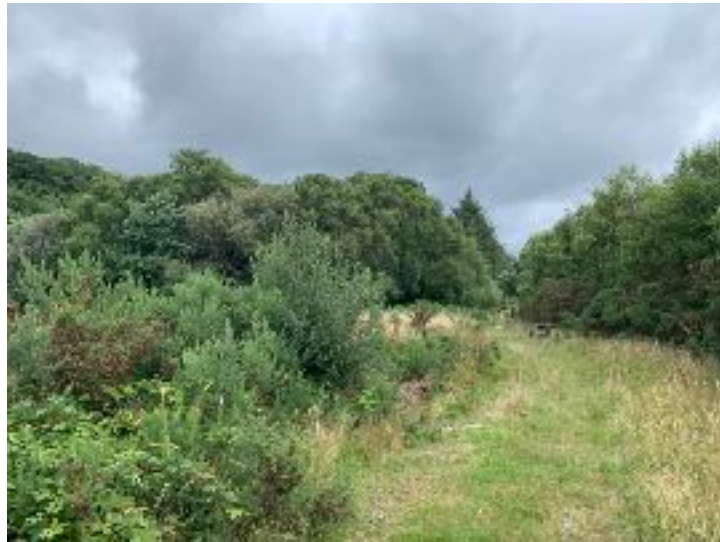
Fig 4: Lakeside approach to second gate

Prior to the second gate into the main development site, there is a maturing woodland block of oak and birch on the north side of a drainage ditch. In order to access the site, a 5m wide by 6m high clearance will need to be created to either side of the track centreline, and smaller tree groups along the lake edge may need to be laterally cut back. Any overhanging branches in the woodland group (G6) may also need to be cut back.

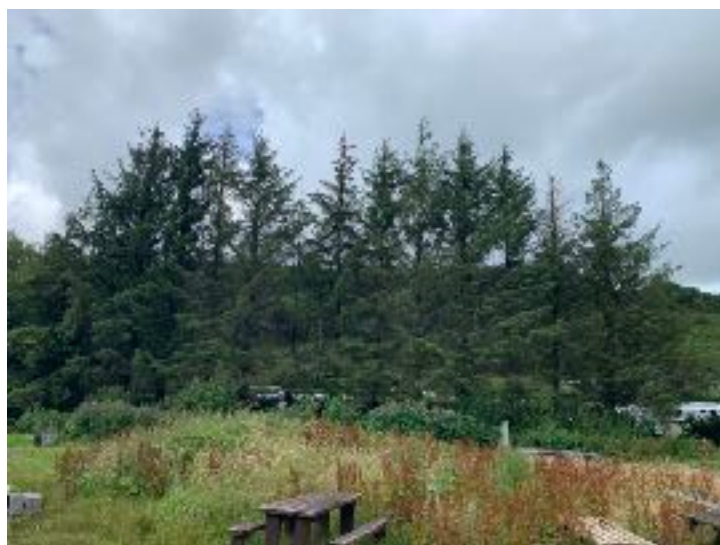
Fig 5: Spruce on northern boundary. Western extent.

The northern boundary of the main development field, which separates it from the active caravan site, initially comprises a linear feature of Sitka spruce. The trees are relatively mature and average from 18 to 22 metres in height. Some of the spruce in these groups are either dead or dealing and will need to be removed for non-development reasons. Some lateral branches to 6 metres height may need to be cut back if access is impeded to the south. The eastern half of this feature comprise Sitka spruce, Lawson cypress, Monterey cypress willow and alder, in generally fairly good condition. The golden Monterey cypress in the eastern corner are generally in poor condition, and should be removed in order to access the existing gate.

7	Some lower laterals of T8-T21 may need to be pruned back to a height of 5 metres.	Remove prior to work commencing.
8	The spruces T22-T25 have died off, and may pose a hazard to site operatives.	Prune up branches of spruces to 5m along entire northern boundary.
9	G15 Multi-stemmed cabbage palm in decline.	Obstructs layout, and is of limited aesthetic or conservation interest. Remove.
10	G16 Scrubby group of thorns, bramble and assorted scrub.	Obstructs layout, and is of limited aesthetic or conservation interest. Remove

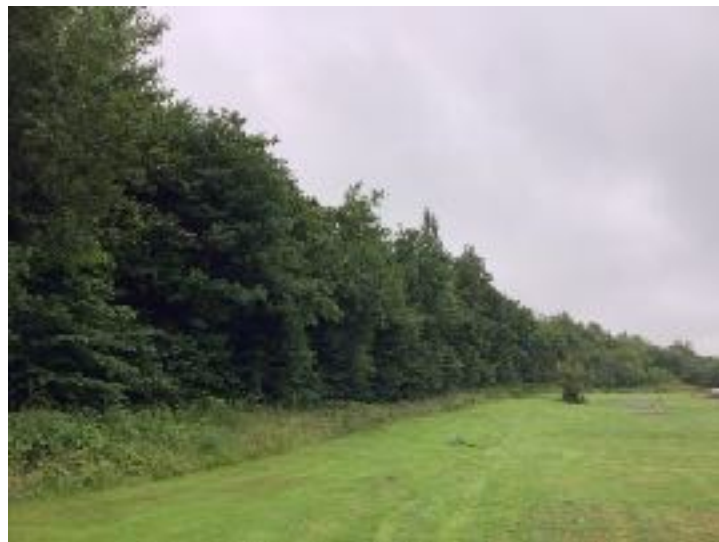
This substantial planted feature is essentially a linear woodland, which provides vital connectivity between existing woodland blocks to the south. Unlike many highway plantings I see, this one is a thoughtful and well-proportioned mix of hazel, oak, field maple, alder, birch, cherry and sensible shrub species. It is functionally and structurally diverse, and its value is likely to increase over time. The proposed construction in this area appears suitably located away from the relatively small RPAs. Nevertheless, the feature should be protected and any lateral branches which may be contacted by site equipment, should be pruned back.

Fig 6: Planted linear woodland along A4087
