INFILTRATION TESTING REPORT

Report Reference: 518 – R1

PROPOSED EXTENTION TO THE SPRING GARDENS
HOLIDAY PARK, ST ASAPH

MÔN CIVILS
LIMITED

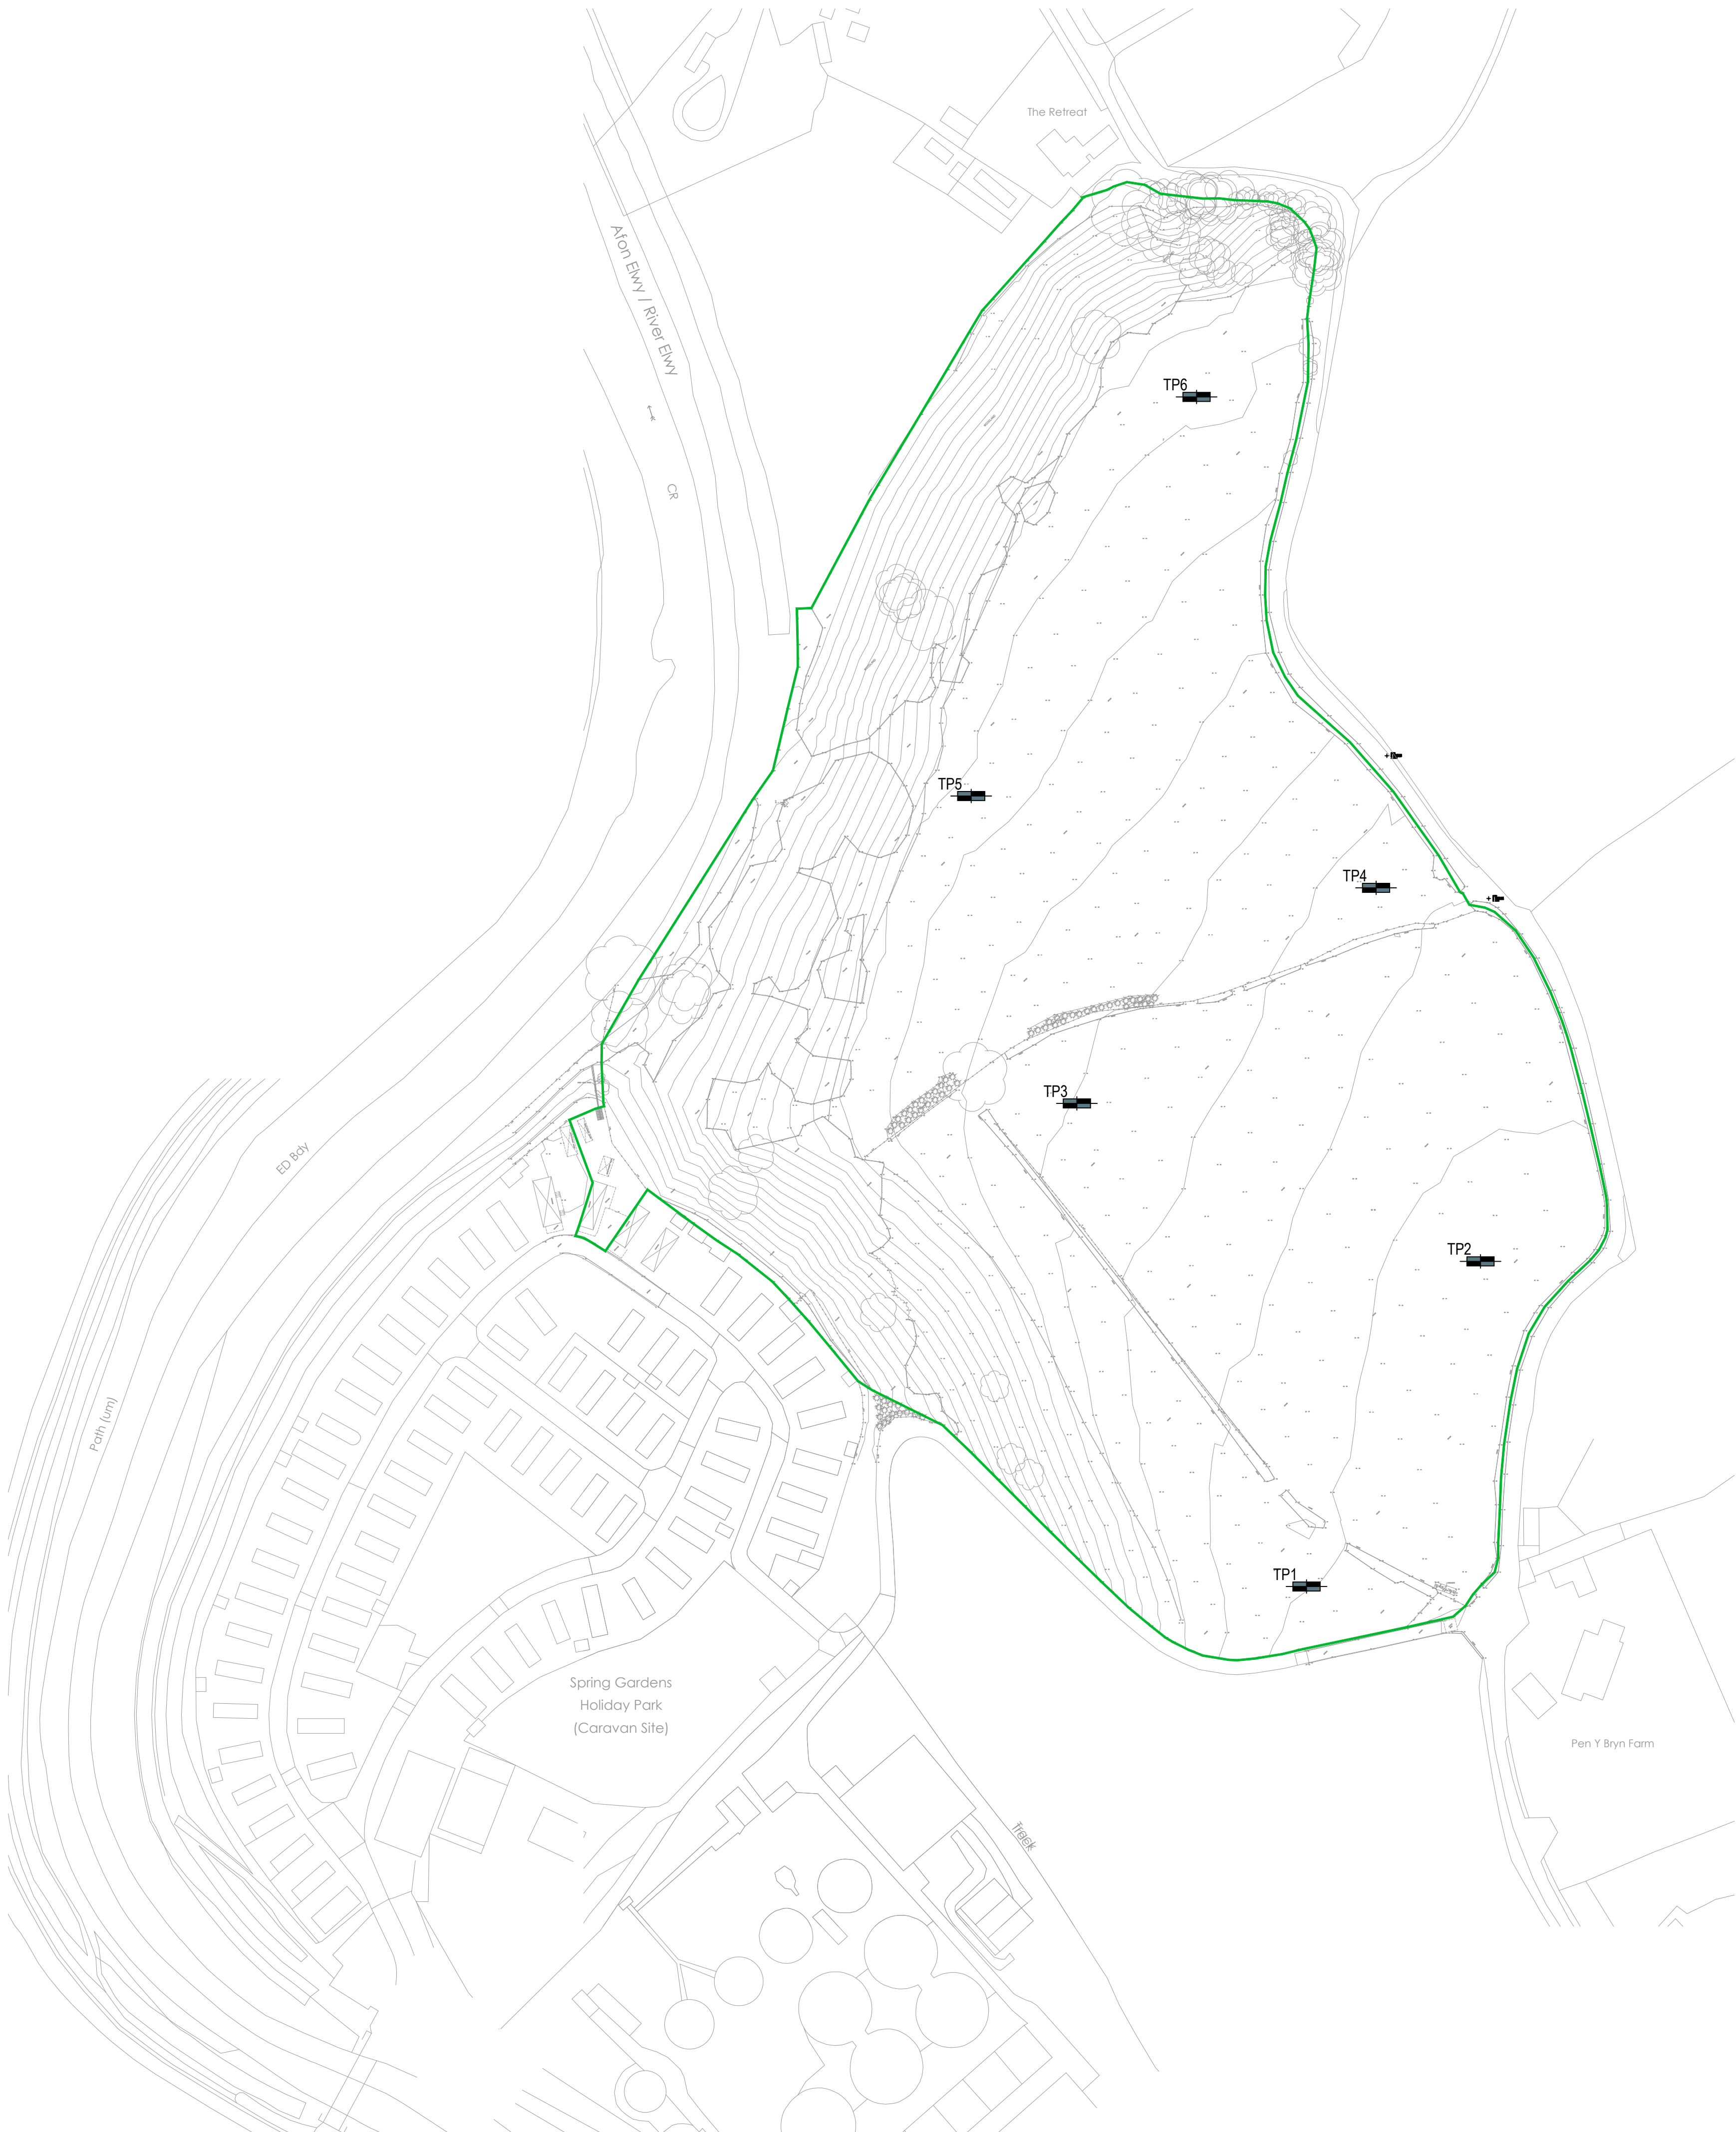
Trial Pit Location Plan

- DENOTES PROPOSED SITE BOUNDARY
- TP# TRIAL PIT LOCATION.

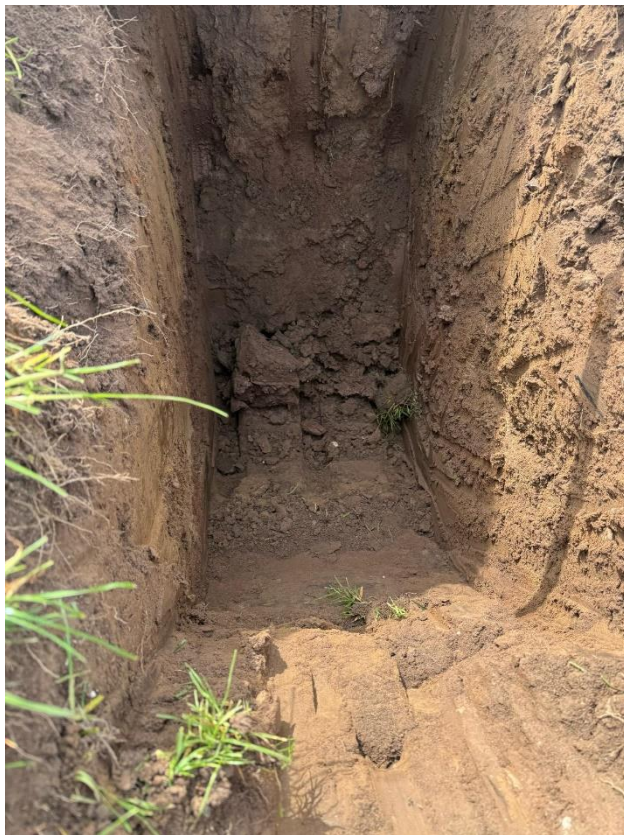
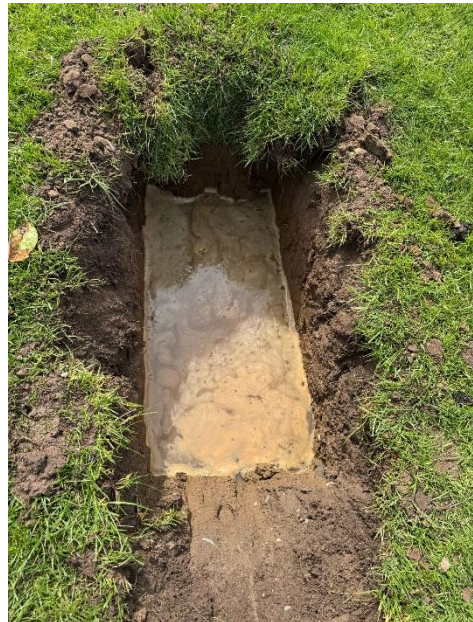
Trial Pit 1 (TP1)

0.000m – 0.300m	Topsoil: loses sandy, clayey, SILT with occasional fine angular gravels.
0.300m – 0.800m	Very Silty, slightly clayey SAND with occasional fine to small angular gravels.
0.800m – 1.100m	Very sandy, slightly silty, CLAY.

1. Trial pit dimensions: 1.300m (L) x 0.500m (W) x 1.100m (D)
2. No ground water was encountered within the trial pit.
3. Sides of trial pit where stable throughout.

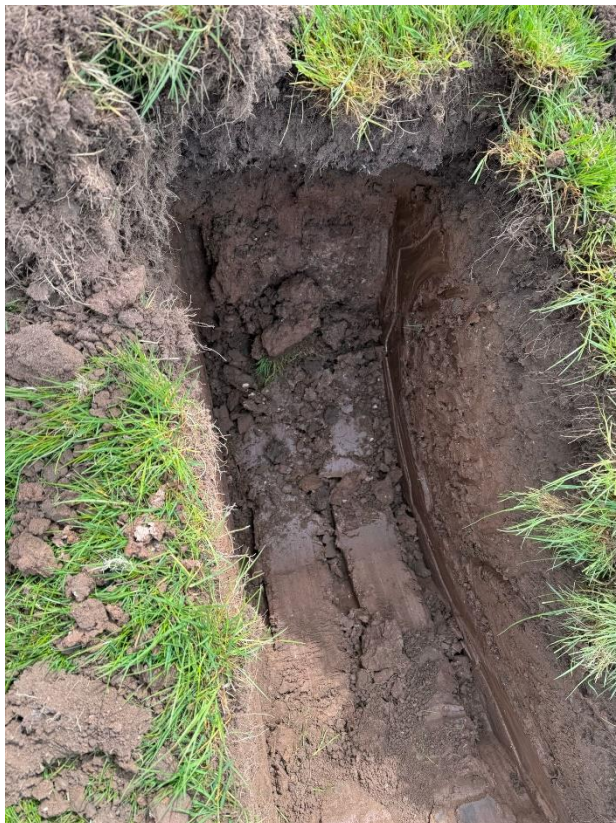
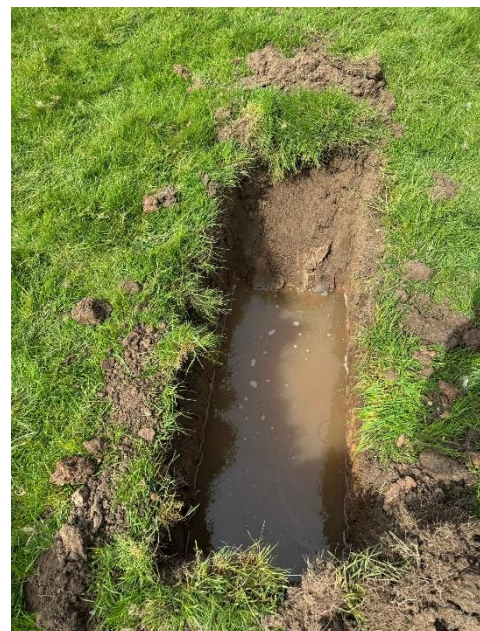
Trial Pit 2 (TP2)

0.000m – 0.250m Topsoil: loses clayey, SILT with occasional fine angular gravels.

0.250m – 0.900m Very Firm CLAY with occasional small to fine angular gravels.

1. Trial pit dimensions: 1.300m (L) x 0.500m (W) x 0.900m (D)
2. No ground water was encountered within the trial pit.
3. Sides of trial pit where stable throughout.

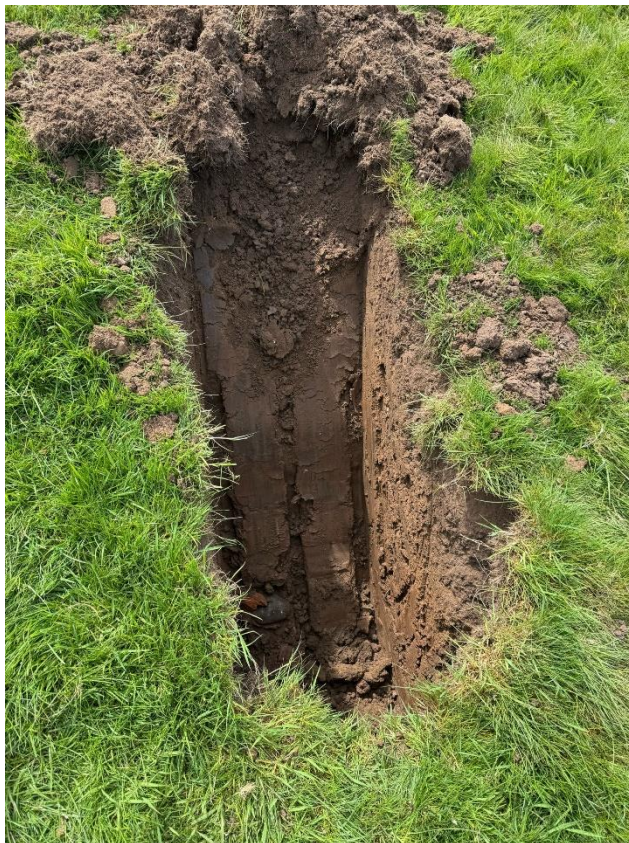
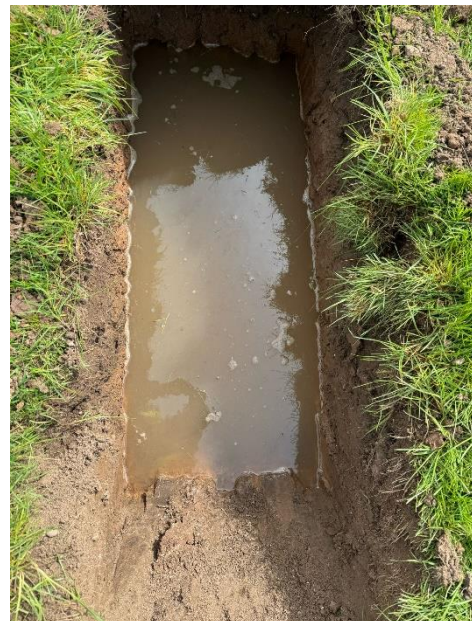
Trial Pit 3 (TP3)

0.000m – 0.360m Topsoil: loses clayey, SILT with occasional fine angular gravels.

0.360m – 1.000m Very Firm CLAY with occasional small to fine angular gravels.

1. Trial pit dimensions: 1.300m (L) x 0.500m (W) x 1.000m (D)
2. No ground water was encountered within the trial pit.
3. Sides of trial pit where stable throughout.

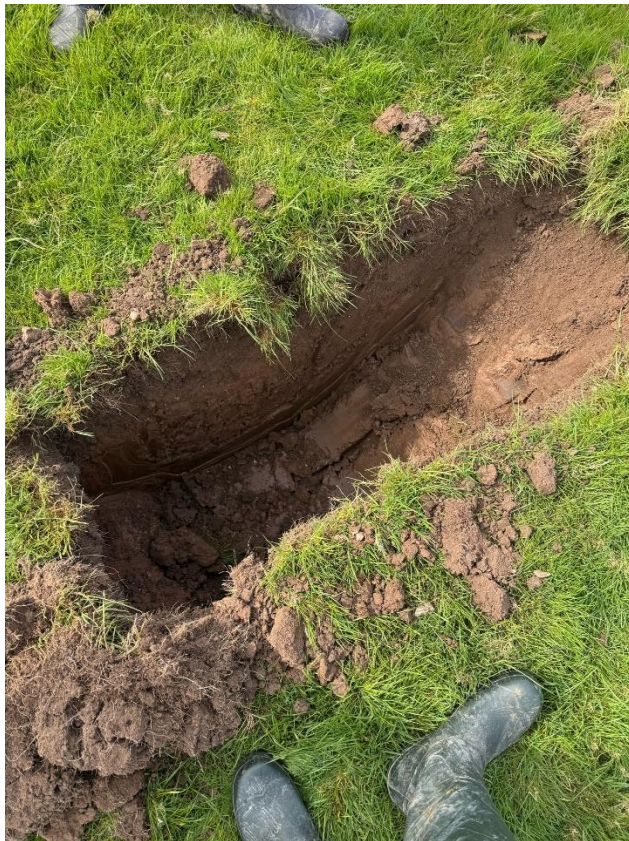
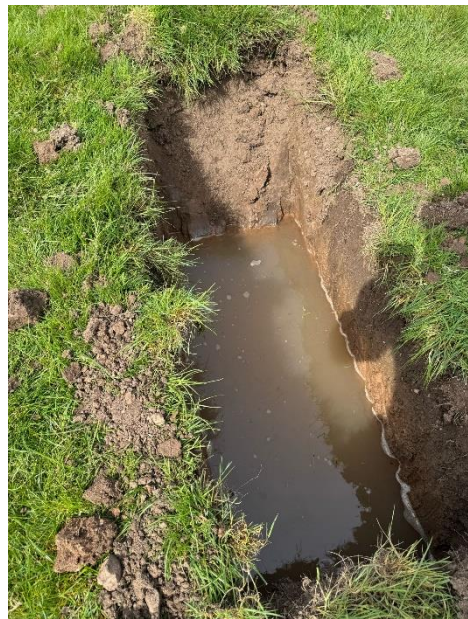
Trial Pit 4 (TP4)

0.000m – 0.300m	Topsoil: loses clayey, SILT with occasional fine angular gravels.
0.300m – 1.200m	Very Firm CLAY with occasional small to fine angular gravels.

1. Trial pit dimensions: 1.200m (L) x 0.500m (W) x 1.200m (D)
2. No ground water was encountered within the trial pit.
3. Sides of trial pit where stable throughout.

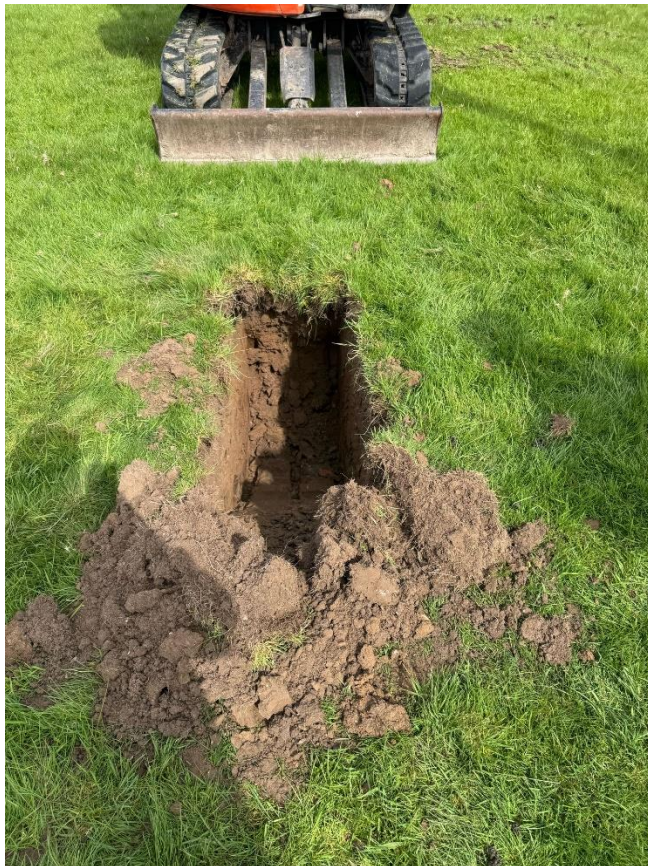
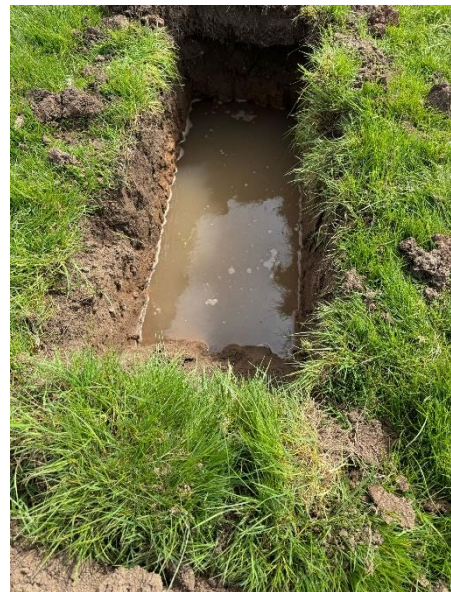
Trial Pit 5 (TP5)

0.000m – 0.270m Topsoil: loose clayey, SILT with occasional fine angular gravels.

0.270m – 1.100m Very Firm CLAY with occasional small to fine angular gravels.

1. Trial pit dimensions: 1.300m (L) x 0.500m (W) x 1.100m (D)
2. No ground water was encountered within the trial pit.
3. Sides of trial pit where stable throughout.

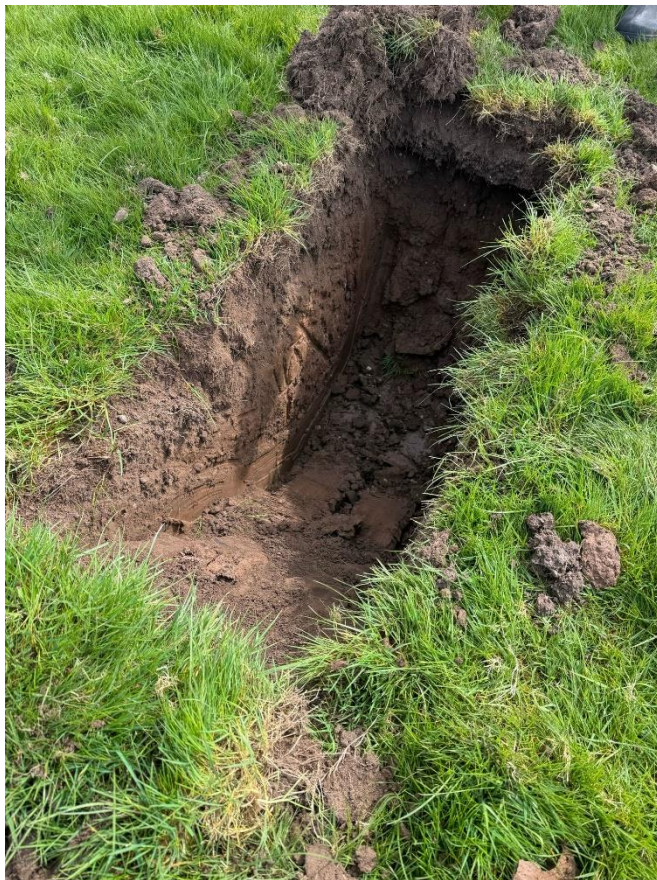
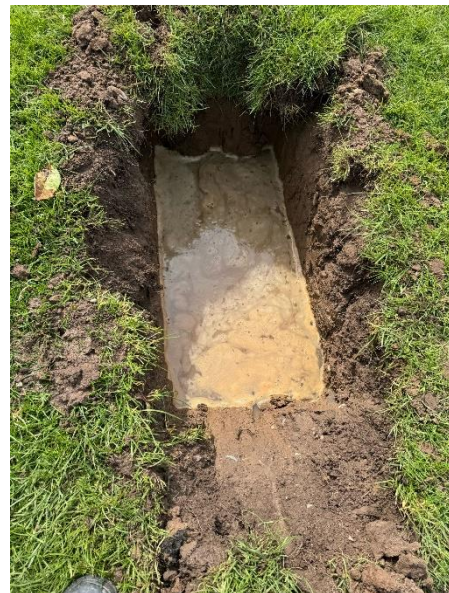
Trial Pit 6 (TP6)

0.000m – 0.310m Topsoil: loess clayey, SILT with occasional fine angular gravels.

0.310m – 1.050m Very Firm CLAY with occasional small to fine angular gravels.

1. Trial pit dimensions: 1.150m (L) x 0.500m (W) x 1.050m (D)
2. No ground water was encountered within the trial pit.
3. Sides of trial pit where stable throughout.
