**Tan y Graig Farm, Pentraeth**  
**ENABLING DEVELOPMENT STATEMENT**  
Grŵp Amos Cymru Cyf  
April 2024  
2017.057\_03

## Enabling Development Statement

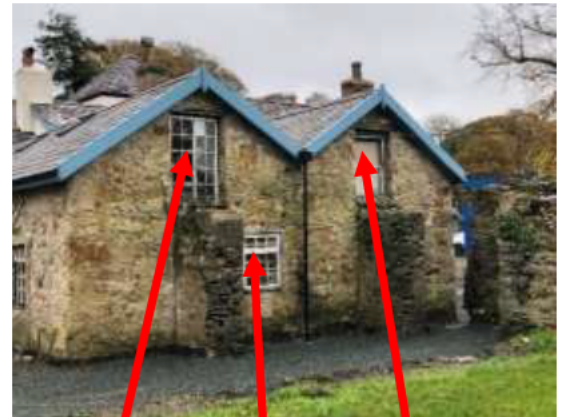
The westerly double gable (Photo 10) has outriggers at the centre of each gable, their purpose is unclear however it is possible that they were originally part of an outbuilding complex to the rear of the property, they are not keyed into the gable and the intention is to remove them.

The bond in the stonework between the two gables is poor in places with a continuous joint with no mechanical bond evident above the ground floor window. This joint is to be deep packed and pointed with consideration given to installing joint reinforcing bars.

The lintels to the windows are timber and are to be assessed as to their condition, where possible lintels will be treated and retained.

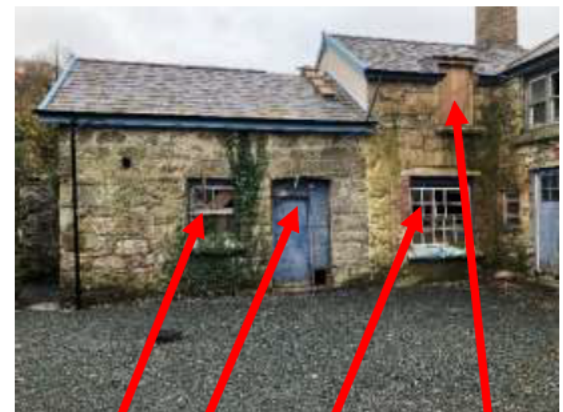
To the South elevation of the Courtyard (Photo 11) large sections of render were missing to the recessed elevation within the courtyard allowing for ivy growth to establish itself and for biological growth to stain the stonework.

This section of the elevation consisting of the former stables and coach house is entirely stone with the exception of the infill within the arched entrance around window W12 to the former coach house which has brick around the window.

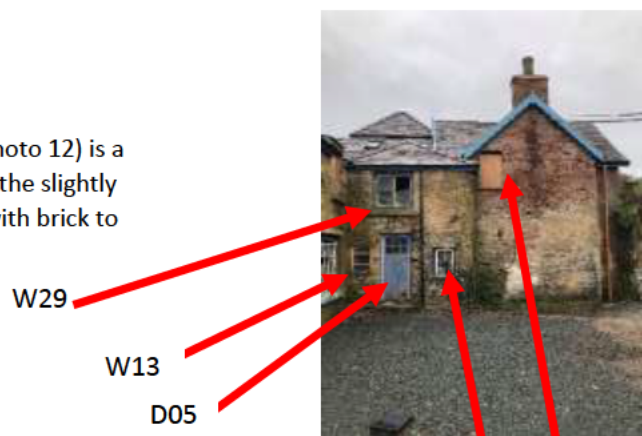
The masonry to the West elevation of the Courtyard (Photo 12) is a mixture, the left hand gable is constructed using stone, the slightly recessed right hand gable is stone to the ground floor with brick to the first floor which must have been a later addition.

Both gables have patches of brick infills within the stonework with there also being a cement infill within the right hand gable. The masonry to the left hand gable is in poor condition with numerous brickwork infills indicating modifications, this is evident internally where the walls to the porch to Room G12 and Room F10 above were found to be very damp.

Between the two gables and to a lesser extent to the left of the left hand gable there is well established ivy growth which has rooted and taken hold where a large section of render had failed and was missing, biological growth is also evident between the two gables and in the corner with the South elevation, again where large sections of the render were missing. All vegetation and biological growth is to be removed prior to re-rendering.

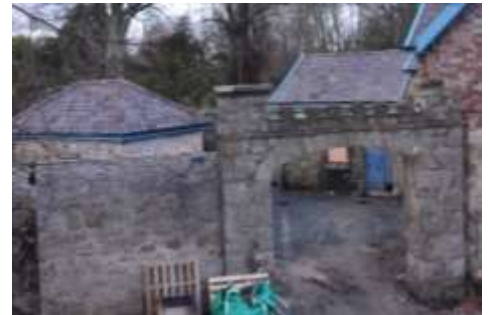
The existing arched and castellated entrance to the courtyard (Photo 13) is to be retained .

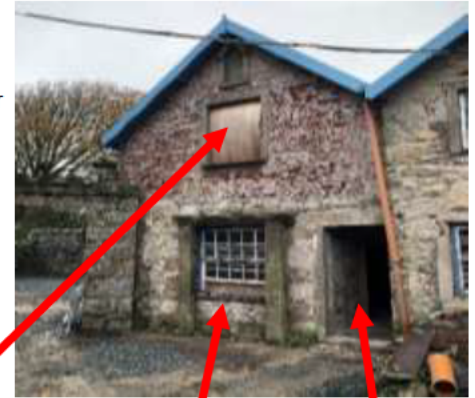
(Photo 15)

The Ground floor window W15 is set within a fine grained sandstone former door surround (Photo 15), other than the surrounds to windows W19 & W23 this is the only sandstone feature to the building with all other window surrounds or features being rendered. It is assumed that this surround is an acquisition from elsewhere and has been incorporated rather than having been an initial element of the designed.

The surround is coming away from the body of the house and will require dismantling and re-fixing with the necessary stainless steel dowel and restraint ties incorporated, the cill to the window is slate and is to be retained.

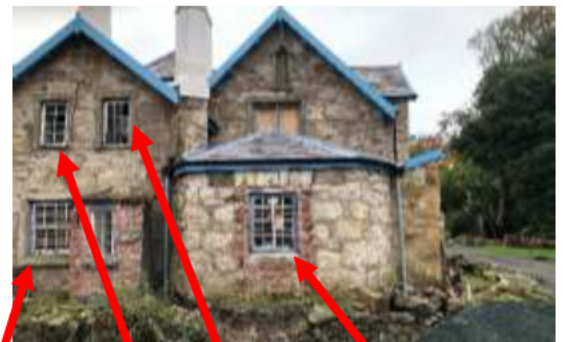
(Photo 16)

The former door opening around window W18 is infilled with brickwork, it is assumed that this originally matched that to door D02 on the North Elevation. The render to the window surround will need to be reinstated including the cast concrete cill.

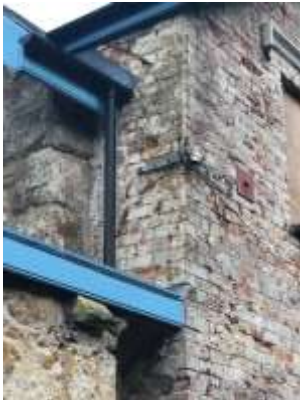
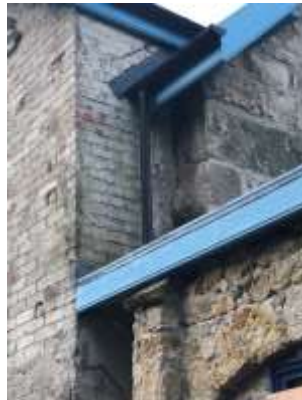
Photo's 18 & 19 showing the external vertical joint between the left and right hand bays and the main house structure, the void between being infilled with cement mortar externally.

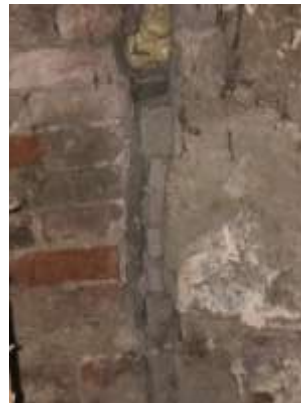
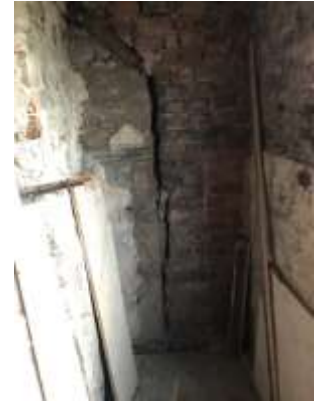
Photo's 20 & 21 showing the external vertical joint between the left and right hand bays and the main house structure.

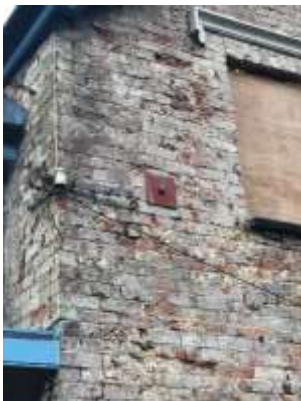
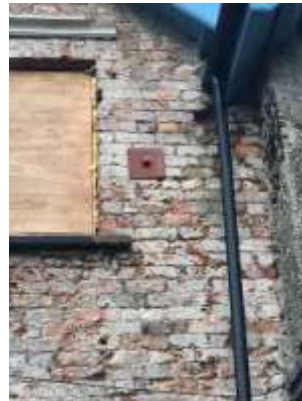
Photo's 22 & 23 showing the modern red oxide painted external pattress plates to the tie bars on the left hand gable. Note also the telecoms bracket in Photo 22, the imposed load of the wiring and wind loading may have contributed to the separation of the gable masonry from the original structure.

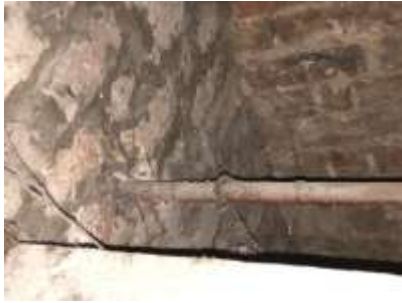
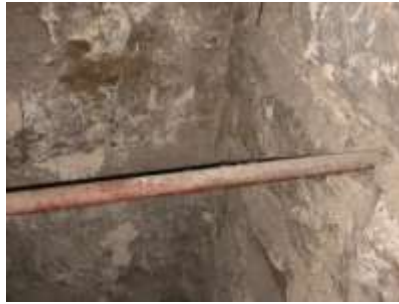
Photo's 24 & 25 showing the tie bar arrangement internally.

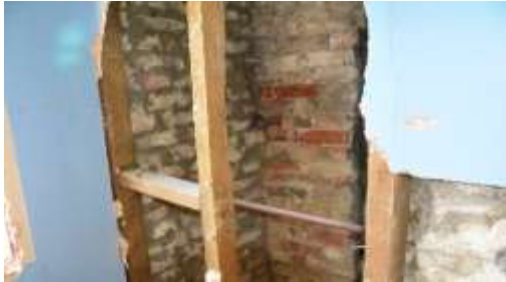
(Photo 26)

Photo 26 showing tie bar within modern stud and plasterboard partition, again thought to be 1980's as part of works following the fire.

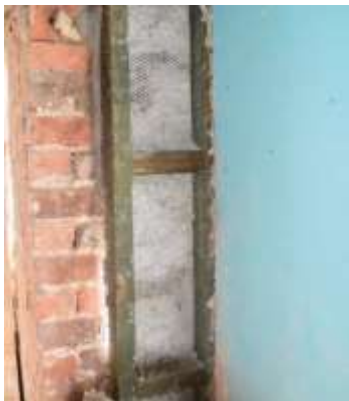
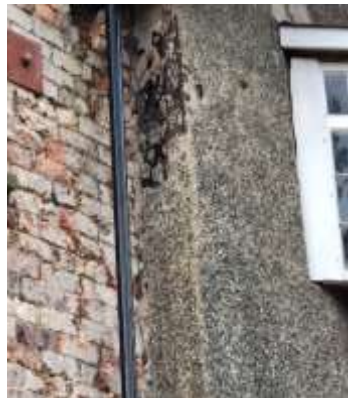
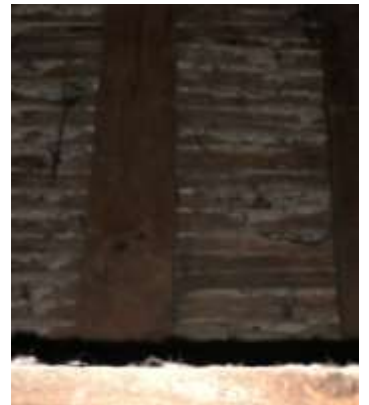
The central projecting gable to the front elevation at First Floor is not of masonry construction but has been found to be studwork to the sides with render of metal mesh (Photo 27), the mesh being evident externally in places (Photo 28) whilst to the front it is lathe and render (Photo 29).

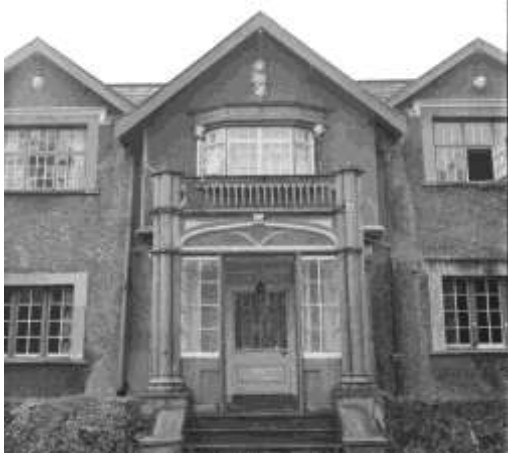
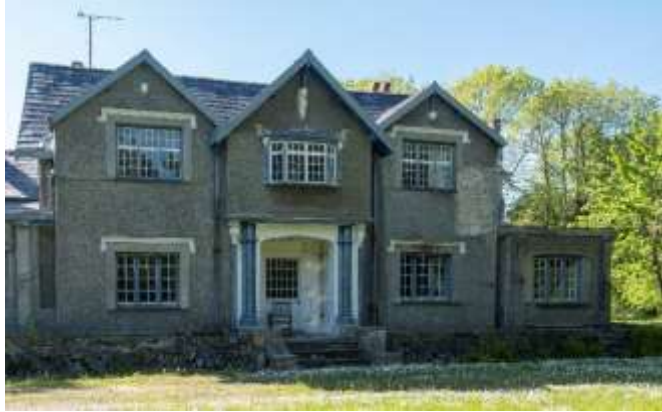
A comparison of the Photo's 31 & 32 indicates that the frontage at least has been re-rendered in the not too distant past, patch repairs evident in Photo 31 cannot be seen in Photo 32 and furthermore the patters plates to the tie bars previously discussed have been rendered over in Photo 32.

The hood mouldings above these window was found to be a mixture of external plaster and fibre glass and will be replicated in external plaster by a specialist plastering sub-contractor. In Photo 31 no hood mould is present to the left hand Ground Floor window and this is the one which is fibre glass, likely to have been added at the time of the re-rendering.

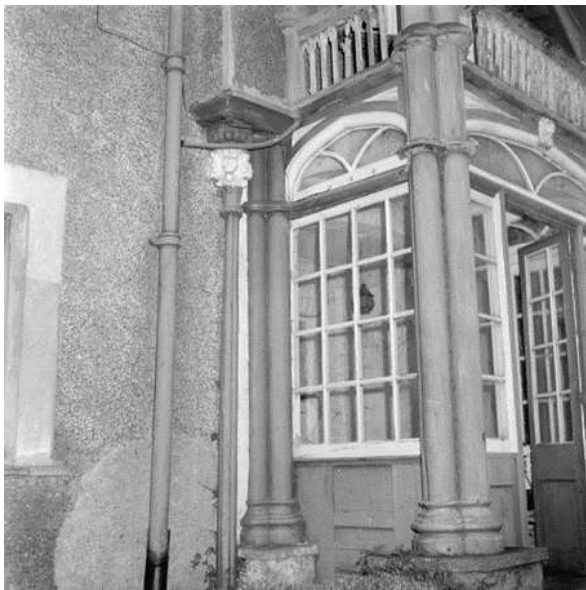
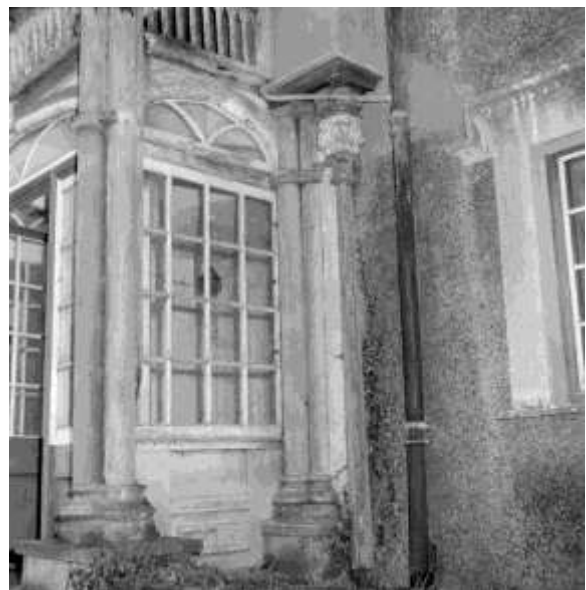
It is proposed to reinstate the porch to replicate the original evident using Photo's 31, 33 & 34 for reference, the intention being that this will return an original feature to the building which in turn will help protect the fresco's and detailing to the main entrance which are currently fully exposed to the elements.

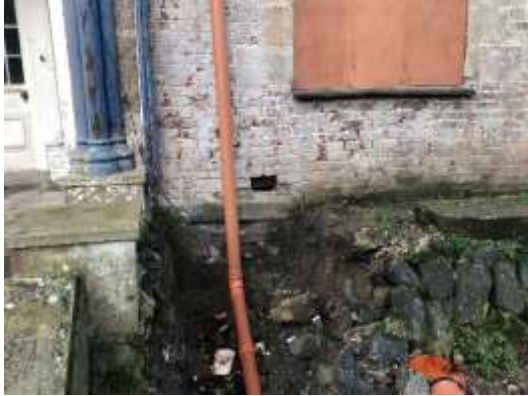
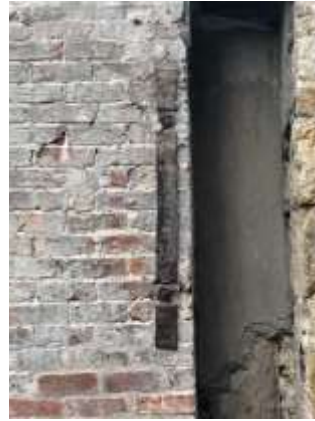
Photo 35 showing the subsidence below the right hand brick bay extension and whilst Photo 36 shows the stitching tie bars to the right where the brickwork has separated from the stonework of the original building.

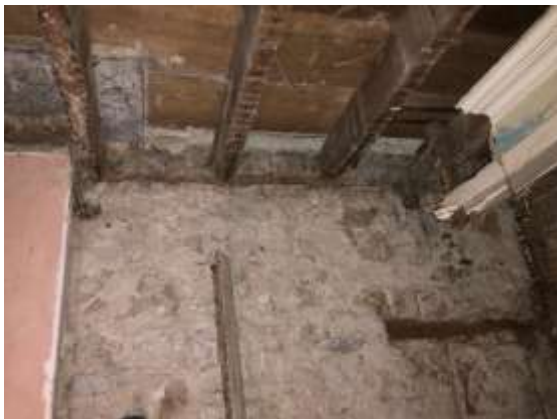
*Photo 38 - Room G1 – Rotten ends to floor joists and bearing timber.*

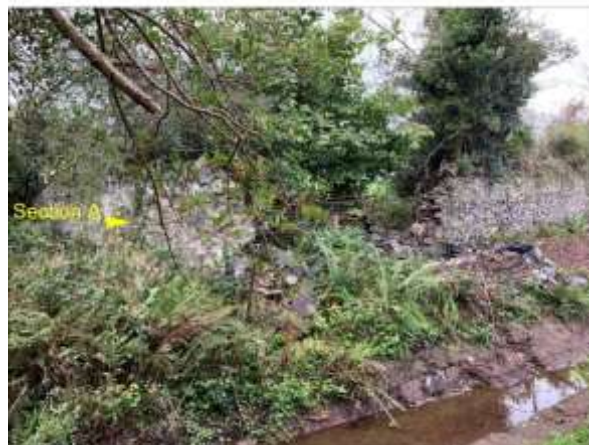
There is extensive vegetation and trees to the rear of this on the farmers side of the wall which will be sending their roots under and helping to destabilise and displace the existing wall.

The Cock and Hen top is still in place as it now stands.

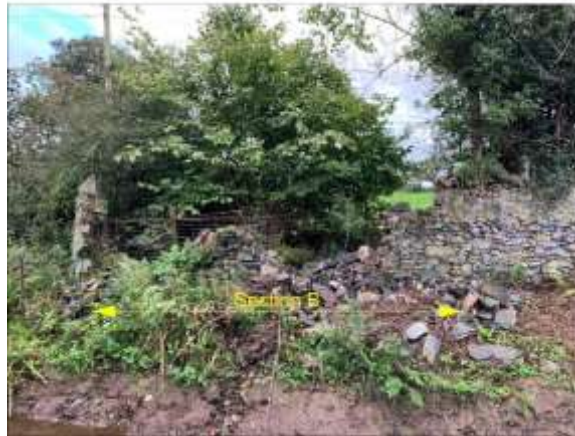
## 4.2 – Section B

There is fencing in place which other parties have installed , I presume to help keep stock within the field behind.

There is walling lying to the house side where it has been pushed from behind either by trees and foliage or live stock.

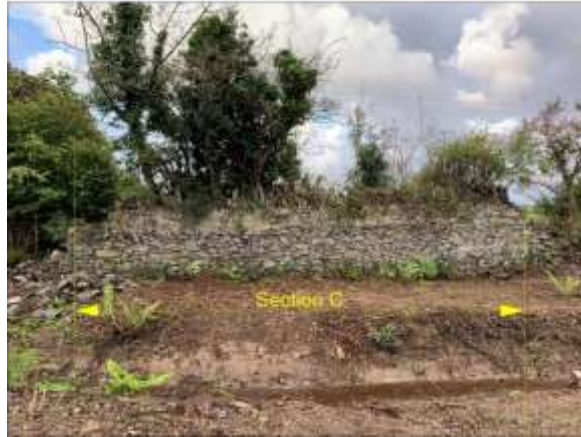
## 4.3 – Section C

11.7 m x 2.1 meters high with Cock and Hen top intact.

This section is in pretty good condition and I would suggest removing the trees asap before they start to displace the existing walling.

Suggest taking the top section down to the original height where the stone colour changes approx. 1.4 meters high and replace the Cock and Hen copings.

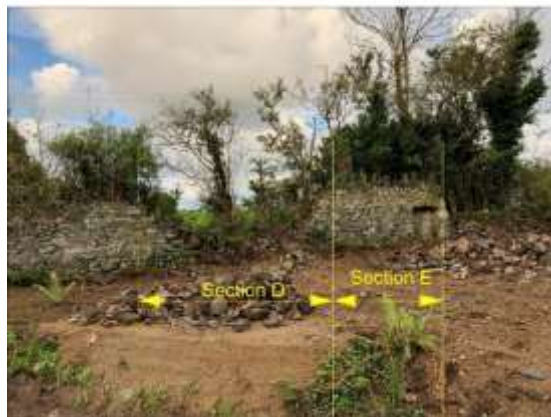
#### 4.4 – Section D

Walling lies on the floor in front of this section.

Take down existing displaced walling. Approx. 5m x .7m.

If we are to install to the proposed original line it would be approx. 5m x 1.4 and reinstate Cock and Hen copings.

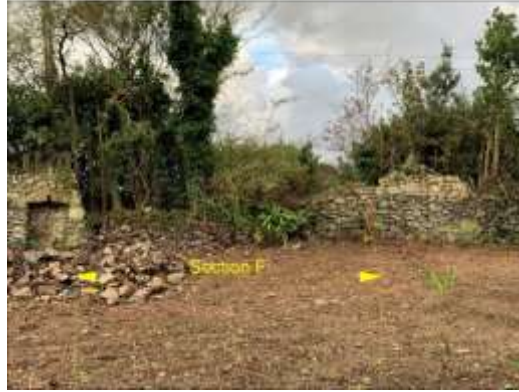
This has been displaced and is in disrepair with the ground and trees / vegetation being higher on the farmers side. Livestock may of also been a factor with ethe collapse. If we are to install to the current height it would be approx.. 2 meters high.

Approx. 8m x 1.4 meters and reinstate Cock and Hen Copings. If not this will be 2 meters in height oif it is to be reinstated to the existing height.

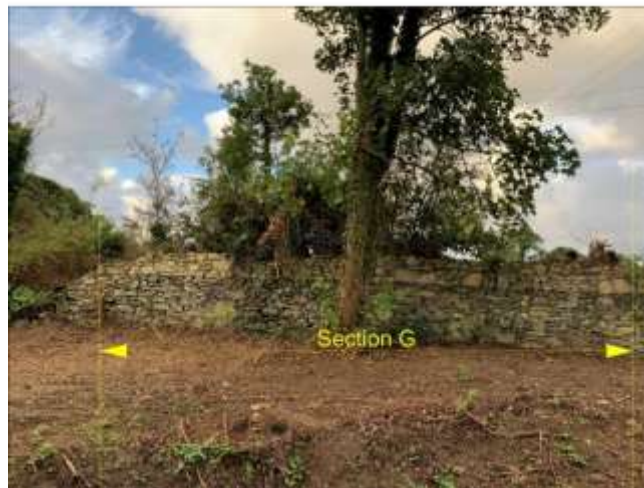
#### 4.7 – Section G

worst case scenario : If the top section is removed and the left hand side of the tree lower section proves unstable then this would need to be rebuilt. Hopefully by removing the top it will stop it pulling it over.

I would propose taking the newer top section down approx. 11m x .6 m and reinstating the Cock and Hen to the top.

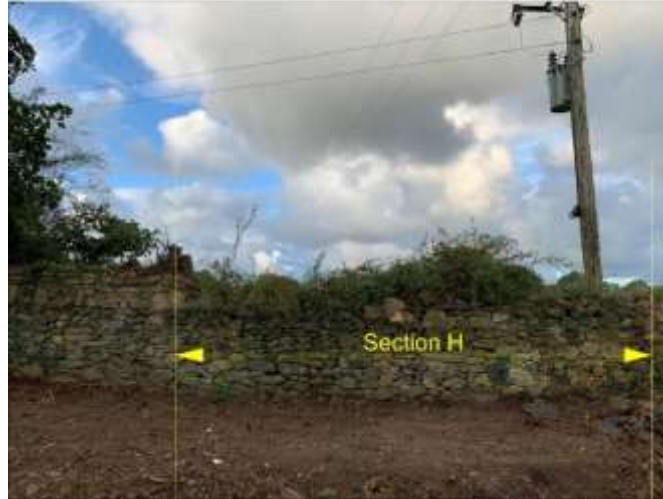
#### 4.8 – Section H

This looks to be in reasonable condition. the top approx.. 7mx 500mm have lost their bond could do with removing and rebuilding with mortar and adding the Cock and Hen copings to the top.

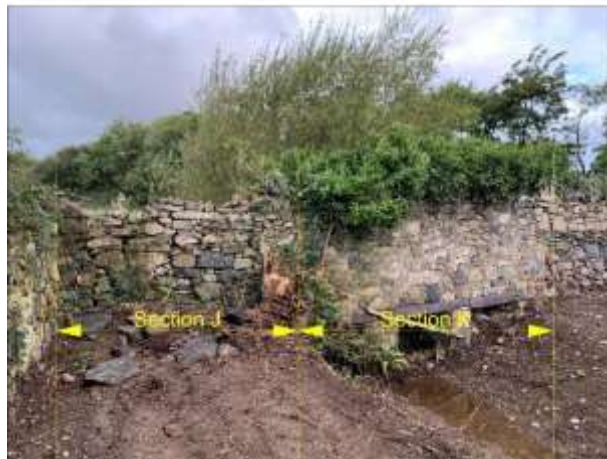
#### 4.9 – Section J

Option J1) Approx.2.5m x 1.2m. This looks to have spread and has been patched at some time further to being dislodged. This is evident from the construction I feel. Take down and re-build full section.

J2) This section can be left and the top 400mm could be dropped and consolidated with the Cock and Hen top added or the full little section dropped and rebuilt 2.5mx 1.4m as J1.

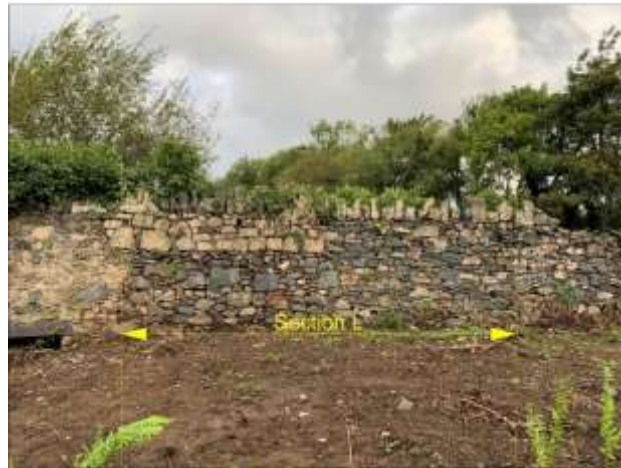
#### 4.10 – Section K

Although at first glances this looks in relatively good condition , the left hand side of this section is leaning backwards and the right and section is leaning back.

This section is to be taken down and rebuilt 100% Approx. 8m x 1.7 re-instating and adding Cock and Hen copings.

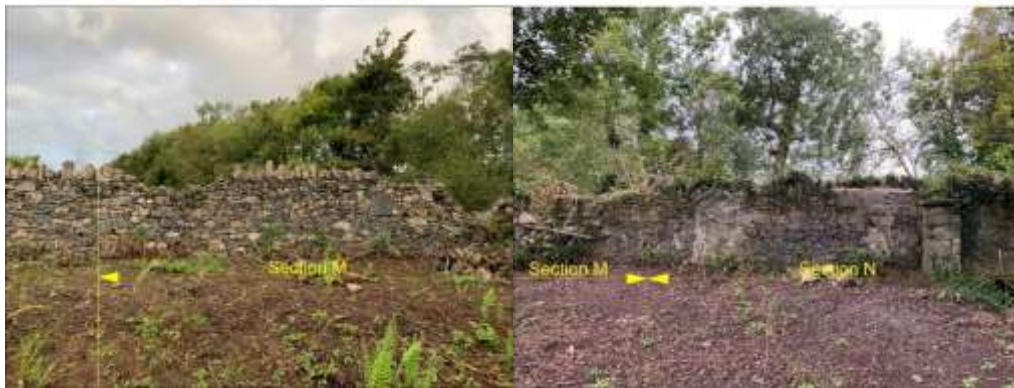
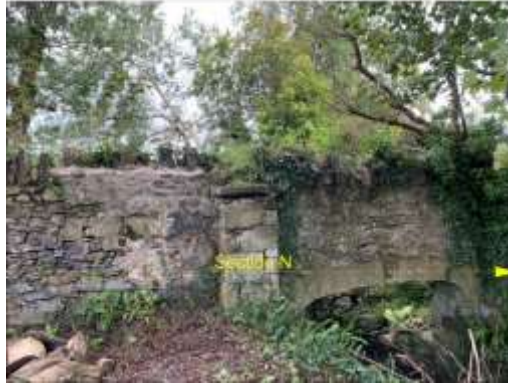
#### 4.11 – Section M

It is also presumed that the natural run off ditch to the back of this wall has been infilled.

We feel that this section of existing wall is to be dropped and re-instated at 1.4 meters in height with the Cock and Hen copings to be added to the top of this. There is a crack at the end of this section which I would take down to at the right hand of section M and rebuild from there to the left hand of section M.
