Bla'en Cefn Temporary Workers Accommodation
National Grid Visual Impact Provision Project-Eryri

Arboricultural Planning Assessment
(BS5837:2012)

Project no: C0233-HUK-GES-CG-AS-X-0001 Rev P02

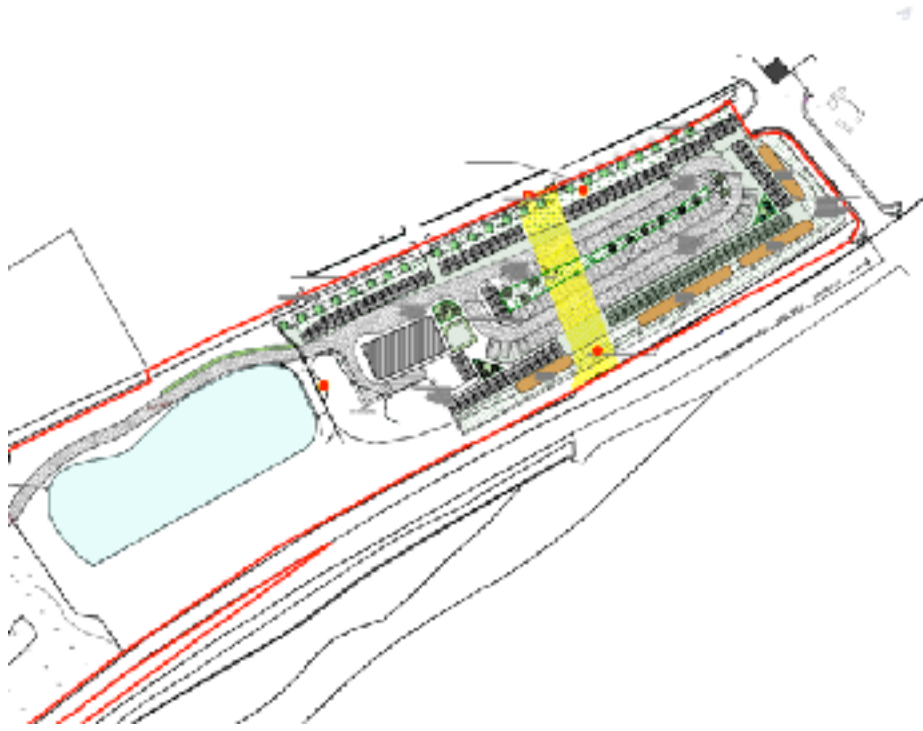
Fig 7: General arrangement

The core of the main field site is to be reconfigured entirely, in order to locate the accommodation units, an internal road network, and sufficient parking for all workers' vehicles. As shown in figure 7, there is a wide gravel apron for the approach from the western end of the site, which also serves the general services building. The driveway then runs parallel to the northern boundary, returns at the eastern boundary and ties back in to the west, forming a road circuit. The development avoids most of the peripheral tree RPAs, and provided fencing is maintained, these important edge trees should not be impacted.
